Maryland Inventory of Historic Properties Historic Bridge Inventory Maryland State Highway Administration Maryland Historical Trust

Maryland Historical Trust
SHA Bridge No. M 120 Name: Griffith Road over Hawlings River
Location: Street/Road Name and Number: Griffith Road
City/Town: Brookville Vicinity X
County: Montgomery
Ownership:State_X_County_MunicipalOther
This bridge projects over:RoadRailway_X_WaterLand
Is the bridge located within a designated district:yes_X_no
_NR listed district_NR determined eligible district _locally designated_other Name of District
Bridge Type:
Timber BridgeBeam BridgeTruss-CoveredTrestleTimber-and-Concrete
_Stone Arch
_Metal Truss
_Movable Bridge _Swing _Bascule Single Leaf_Bascule Multiple Leaf _Vertical Lift_Retractile_Pontoon
Metal GirderRolled GirderRolled Girder Concrete EncasedPlate GirderPlate Girder Concrete Encased
_Metal Suspension
_Metal Arch
_Metal Cantilever
_X_Concrete Arch _Concrete Slab_Concrete Beam _Rigid Frame
_Other Type Name

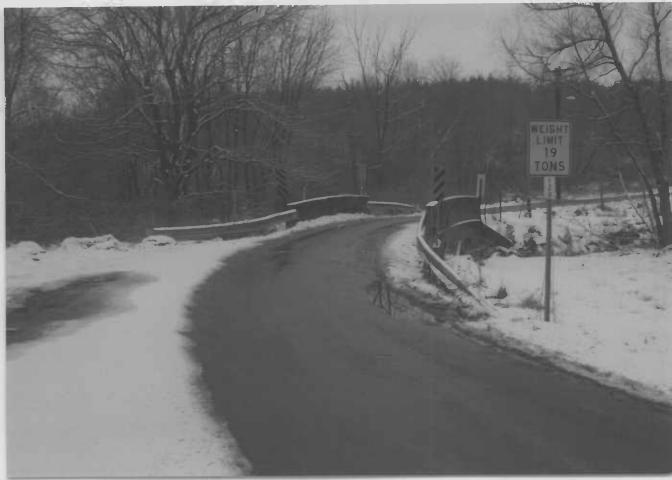
Inventory	#	M:	2	3-	133

M C 80
Name M120-GRIFFITH OVER HAWLINGS BIVER
County/State Montoomery mo
Name of Photographer FRANK JULIANO
Date 2 95
•
Location of Negative SHA
Description Approach WEST
Number Z of 38

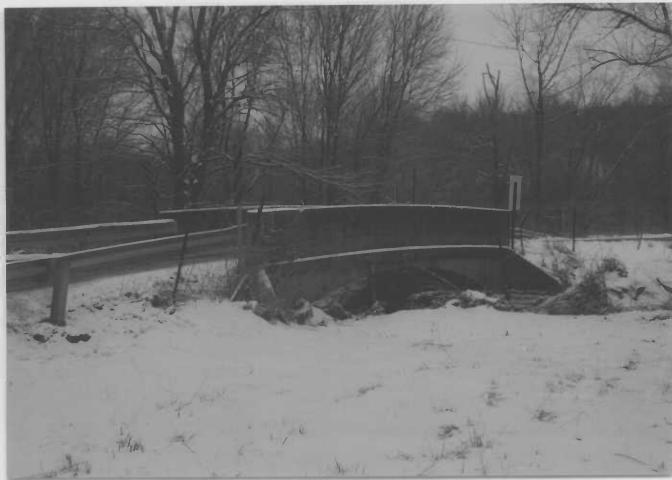
Inventory	#	M:	23	-133
-----------	---	----	----	------

Name MIZO-GRIFFITH RO OVER HAWLINGS RIVER
County/State Montoomery mo
Name of Photographer FRANK JUMANO
Date 2/95
Location of Negative SHA
Description ELEVATION SOUTH
Number of 38

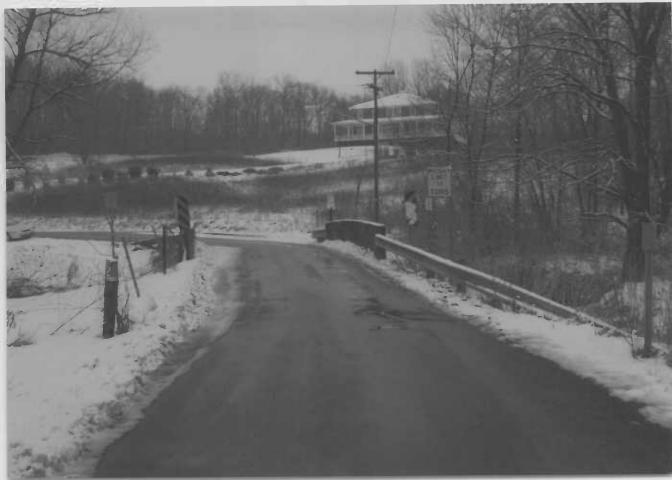
# Inventory # <u>M: 23 - /3</u>3

Name MIZO-GRIFFITH ROOMER Hawkings RIVER
County/State Montgomery mo
Name of Photographer FRANK JULIANO
Date 295
•
Location of Negative SHR
Description APPROACH EAST
0
3 4
Number 4 of 33

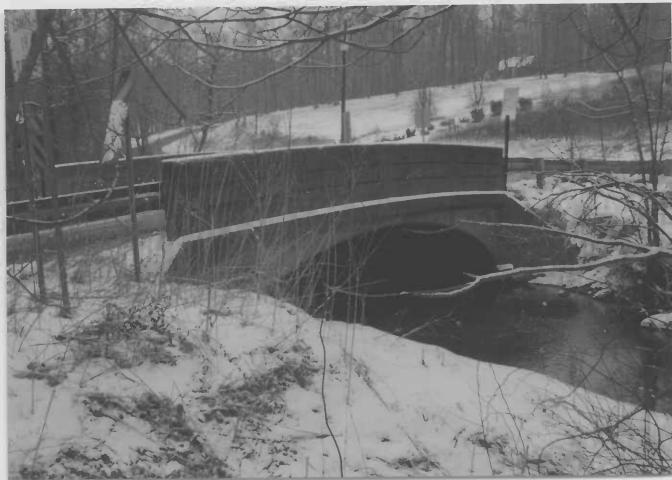
# Inventory # <u>M: 23-133</u>

Name M120-GRIFFITH RD OVER HAWLINGS RIVER  County/State Montgomery mo  Name of Photographer FRANK JULIANO  Date 295
Location of Negative SHA
Description ELEVATION NORTH
Number of 3/3
